Update "With-Site-Visit" Reserve Study

Hudson Trace HOA Tempe, AZ

Report #: 11438-2

Date Prepared: December 11, 2017

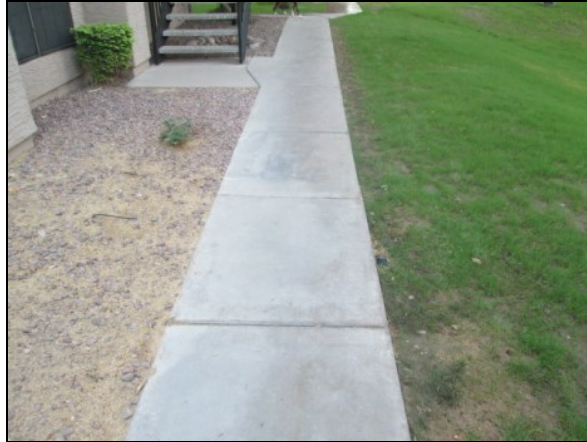
Comp #: 103 Concrete - Repair

Useful Life:
4 years

Remaining Life:
1 years

Allowance for repairs and/or partial replacement
