Update "With-Site-Visit" Reserve Study

Hudson Trace HOA Tempe, AZ

Report #: 11438-2

Date Prepared: December 11, 2017

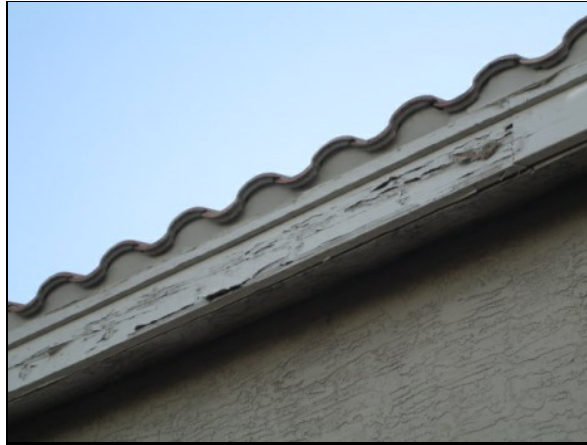
Comp #: 1118 Wood Trim - Repair

Evaluation: Rotted and weathered wood noted. Repairs are scheduled to coincide with repainting. Repair allowance includes replacing and repairing trellises.

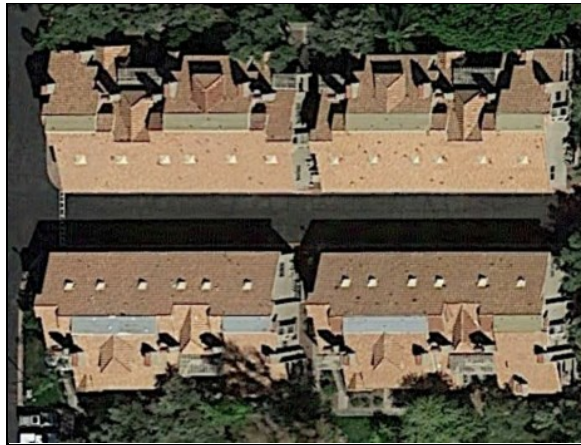
Comp #: 1301 Flat Roofs - Replace

Evaluation: No access to closely inspect. Assumed to be in decent shape with no problems reported. Funding is provided for future replacement.

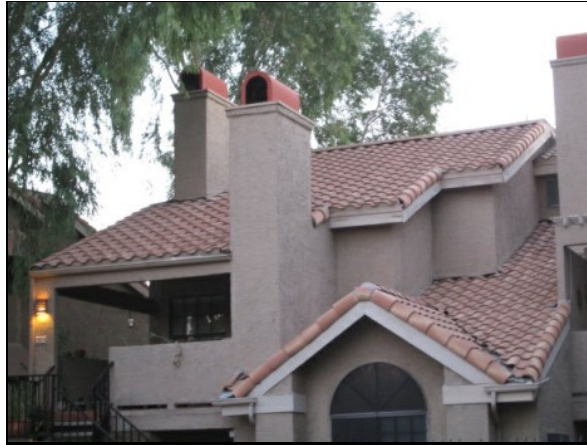
Evaluation: There is no expectancy to refurbish all the tile roofs at the same time in the future. We have split refurbishing into (2) equal phases, to ease the cash flow burden. No problems observed or reported.

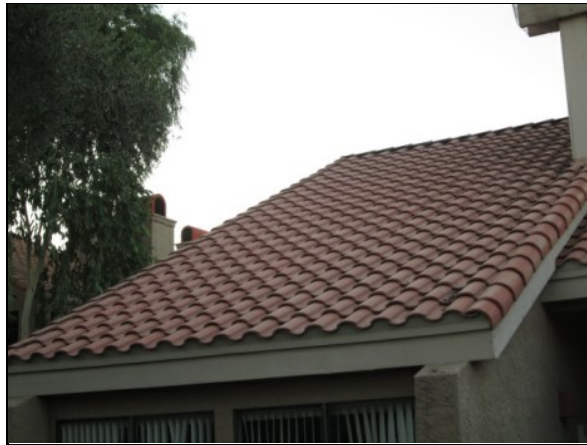
Evaluation: There is no expectancy to refurbish all the tile roofs at the same time in the future. We have split refurbishing into (2) equal phases, to ease the cash flow burden. No problems observed or reported.

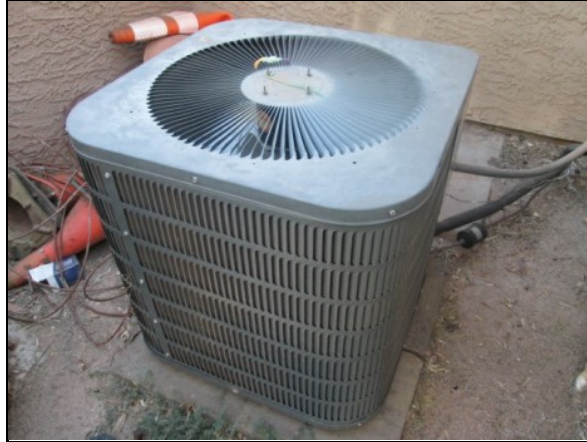
Comp #: 303 HVAC Unit - Replace

History: The condenser was replaced during 2006 for ~\$2,600. The air handler is expected to still be original.

Evaluation: This component provides funding for replacement of both the condenser and air handler together going forward, to maximize efficiency and effectiveness. Model: CKPRT36-1, Serial: 0604672042.

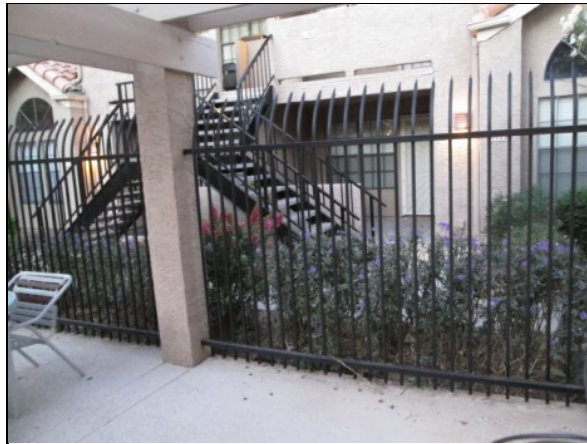
Comp #: 503 Metal Fence - Replace

History: Replaced during 2007 for ~\$5,500.

Evaluation: Still appears stable and secure. Funding is provided for future replacement.

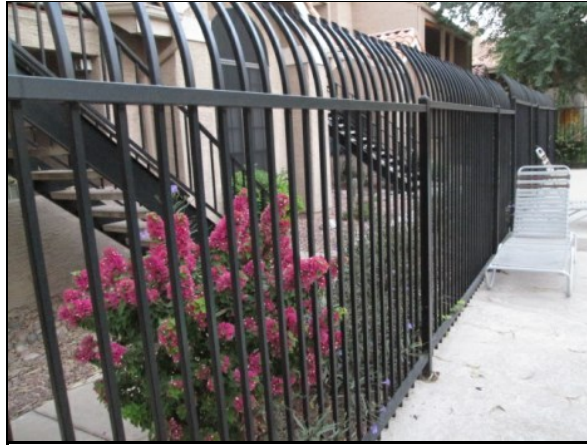
Evaluation: Paint project reportedly has a 5-year warranty. Repaint periodically to maintain the appearance and to inhibit rust.

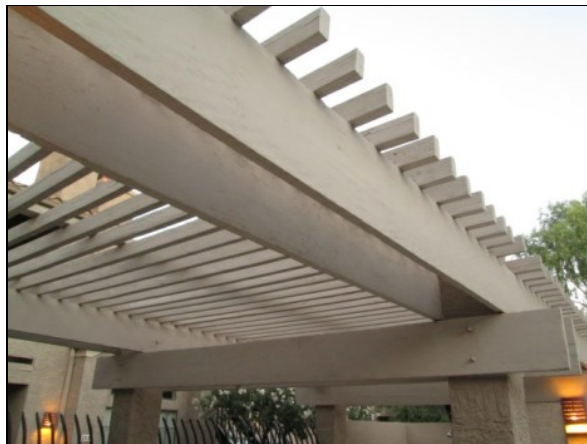
Comp #: 550 Trellis - Replace

History: Repairs were completed during 2009.

Evaluation: Observed to be in fair shape. Funding is provided for future replacement.

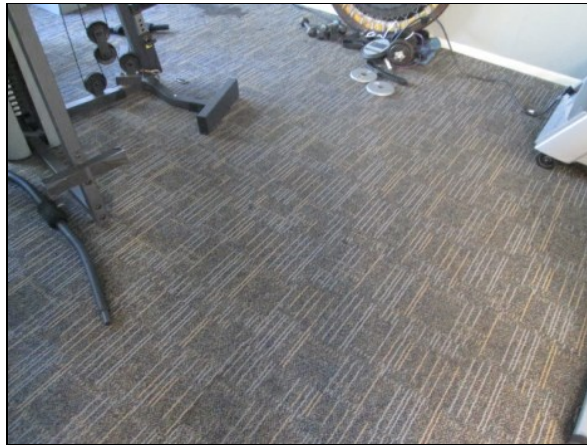
Comp #: 901 Carpet Floor - Replace

Evaluation: The Exercise Room carpet appears newer and in nice shape, while the Meeting Room carpet appears old and worn. Funding is provided for complete replacement in the future, to maintain uniformity.

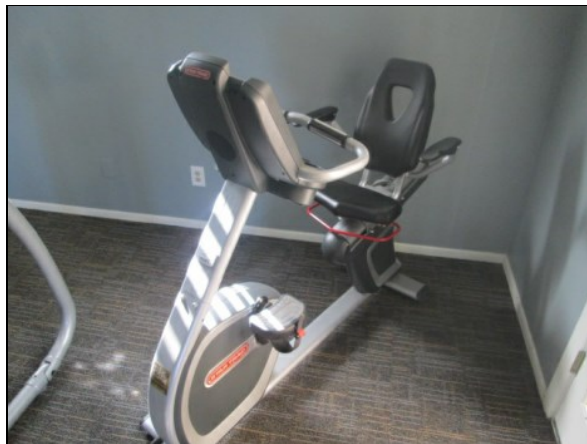
Comp #: 915 Exercise Equipment - Replace

Evaluation: Pieces include (1) Matrix elliptical, (1) Matrix treadmill, (1) StarTrac bike, and (1) Body Solid strength machine. Some pieces are newer, and some are older. This component provides funding for complete replacement eventually, to maintain consistency with the equipment.

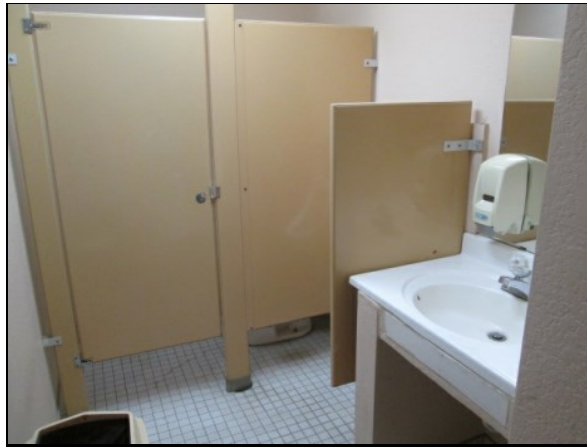
Evaluation: Remodel involves replacing the tile floors, toilets, partitions, sinks, etc. Observed to be dated and worn. Remodeling does not appear to be a high priority at this time, but should still be expected eventually.

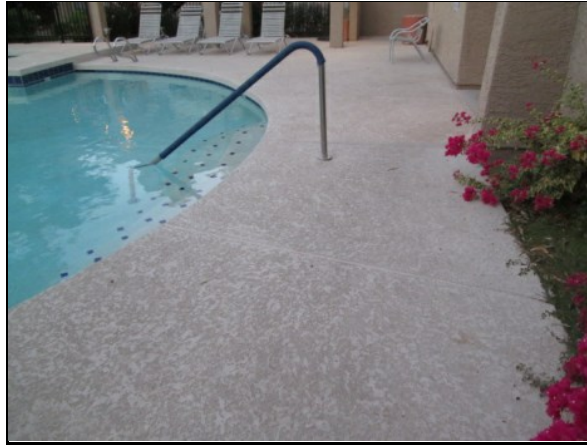
Evaluation: Good conditions noted. Life span is based on periodically sealing and maintaining the deck.

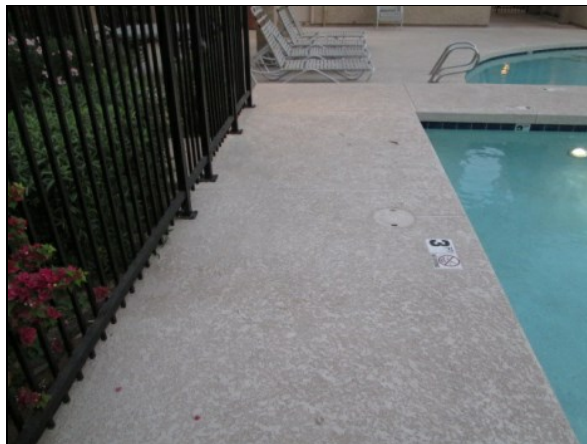
Comp #: 1201 Pool Deck - Seal/Repair

Evaluation: This component funds to periodically patch cracks and seal/paint the deck to cover stains and restore the appearance.

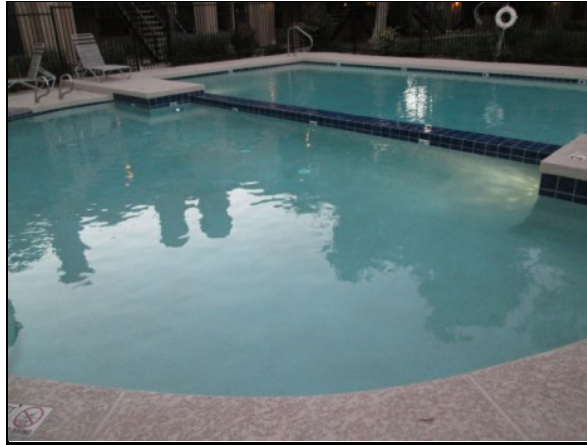
History: Resurfaced during 2007 for ~\$21,600. Waterline tiles were replaced during 2017.

Evaluation: Surfaces are pebble with normal discoloration noted.

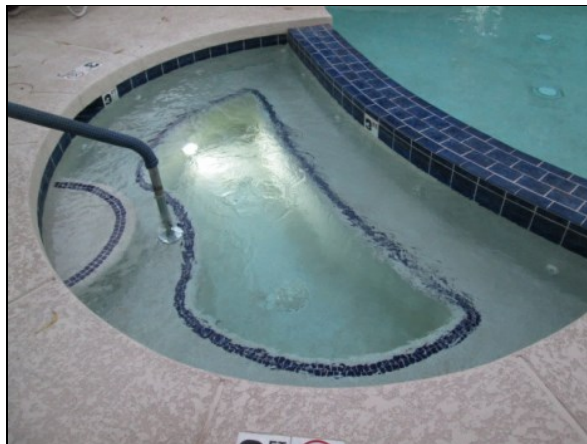
Evaluation: Spa surfaces typically do not last as long as pool surfaces due to higher heat and chemical levels. Discoloration and wear evident.

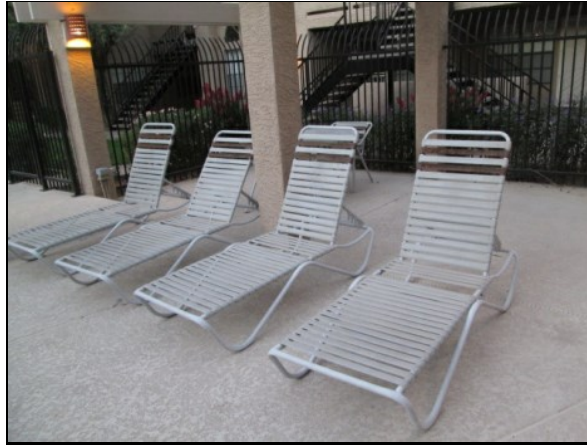
Comp #: 1204 Pool Furniture - Replace

Evaluation: Pieces include (6) lounges, (4) chairs, and (1) table. Observed to be weathered and worn. Recommend planning for replacement soon.

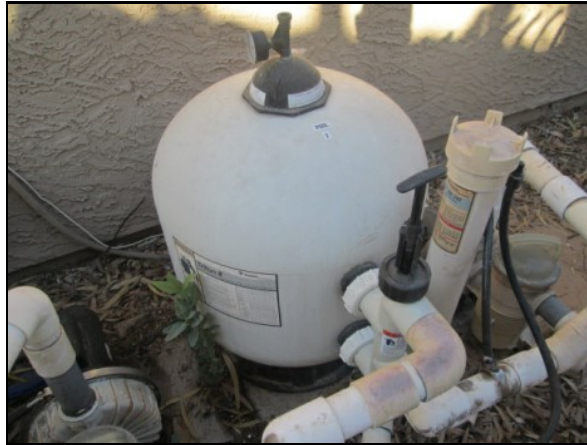
Comp #: 1207 Pool Filter - Replace (B)

Evaluation: Appears weathered and older. Based on age and appearance, it would be prudent to plan for replacement soon.
